# TECHNICAL DAMAGE ASSESSMENT REPORT

**Odessa Maternity Hospital No. 5**

**Building Damage Assessment Following the March 28, 2026 Drone Attack**

May 2026

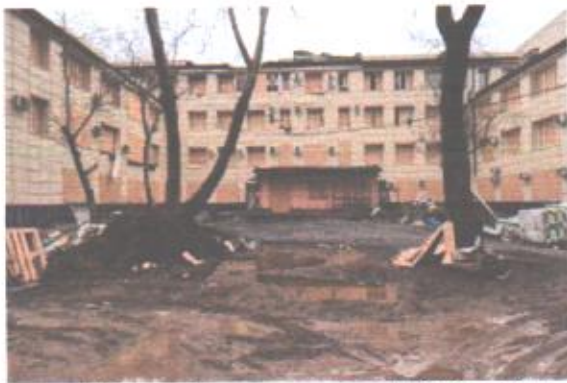
Фото 1 Загальний вигляд пошкоджень будівлі з боку дворового простору

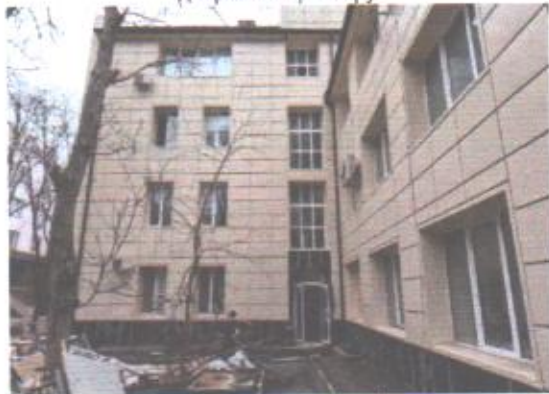
Фото 2 Стан пошкоджень фасаду

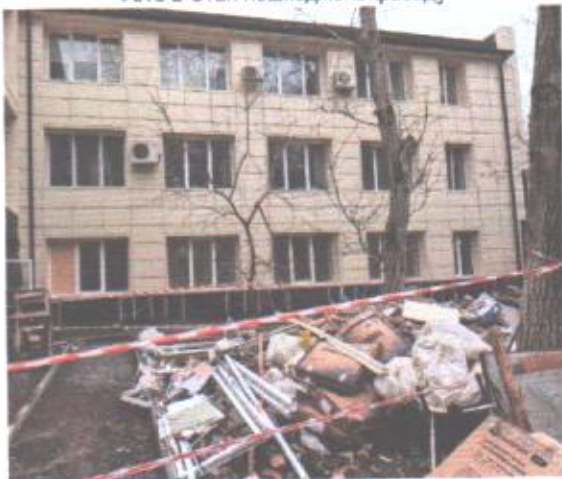
Фото 3 Стан пошкоджень фасаду

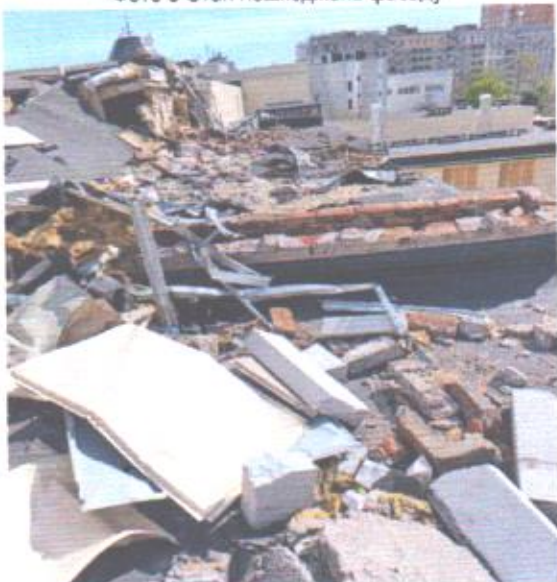
Фото 4 Руйнування надбудови на покрівлі будівлі

Destroyed rooftop technical structures shall be dismantled and removed.

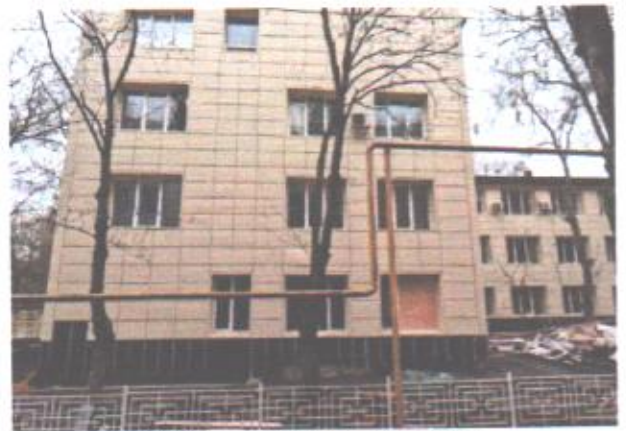
Фото 5 Стан пошкоджень фасаду

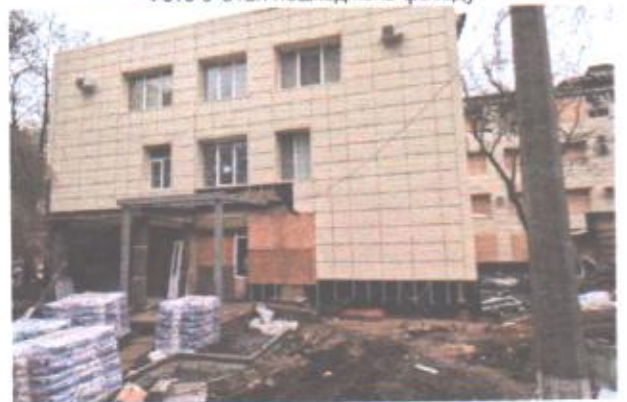
Фото 6 Стан пошкоджень фасаду

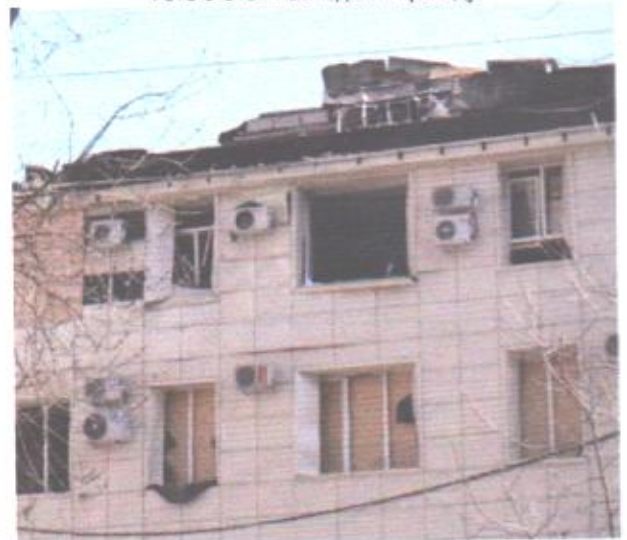
Фото 7 Місце попадання дрону в дах будівлі

Temporary roofing systems shall be installed above exposed areas of the building.

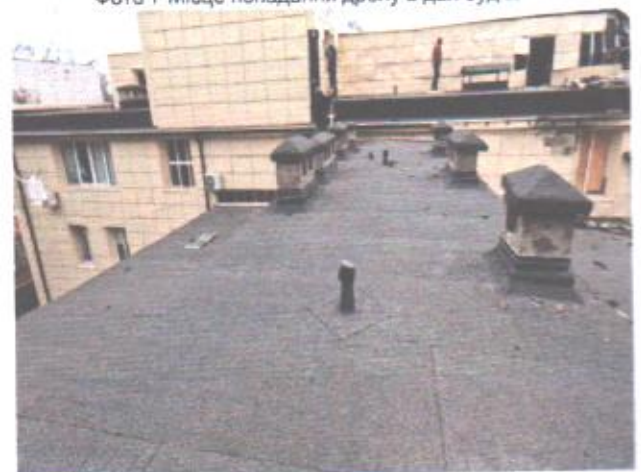
Фото 8 Стан даху з покрівлею

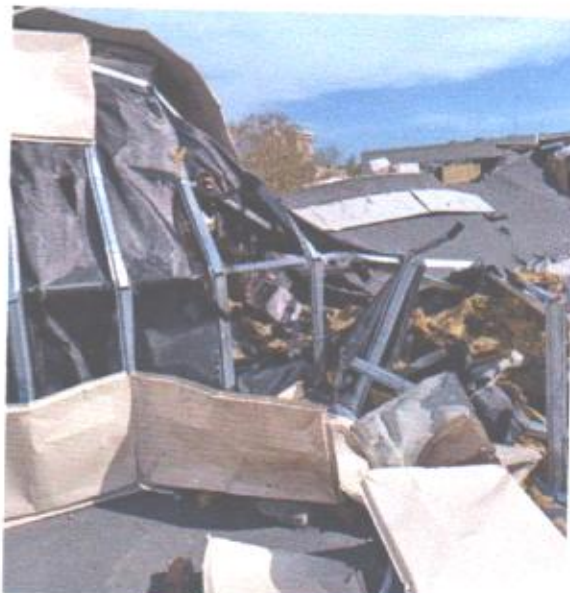
Фото 9 Руїнування надбудови

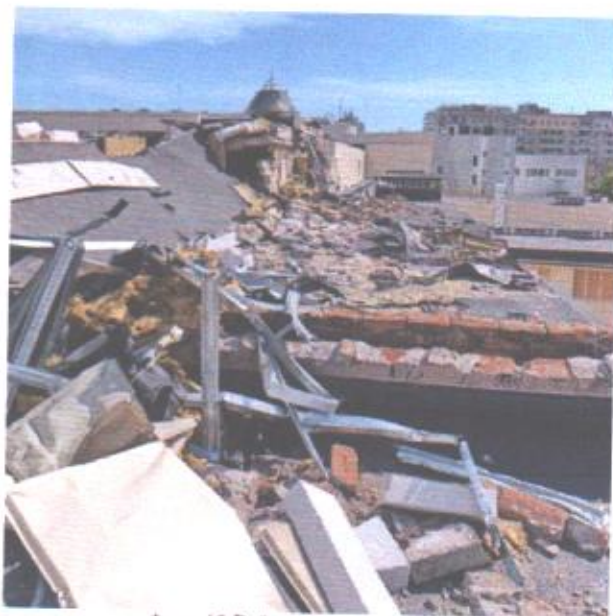
Фото 10 Руїнування надбудови

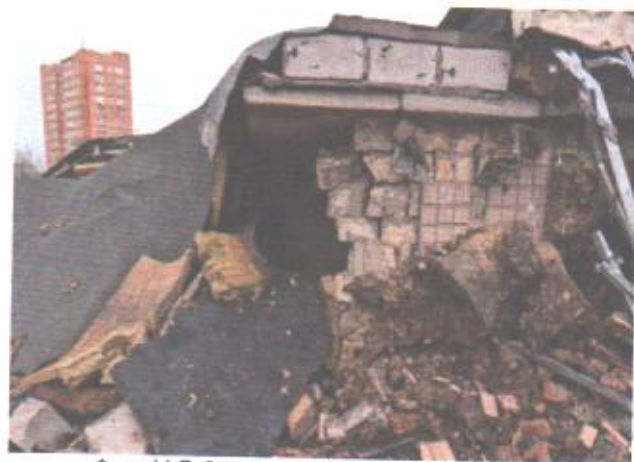
Фото 11 Руїнування конструкцій надбудови

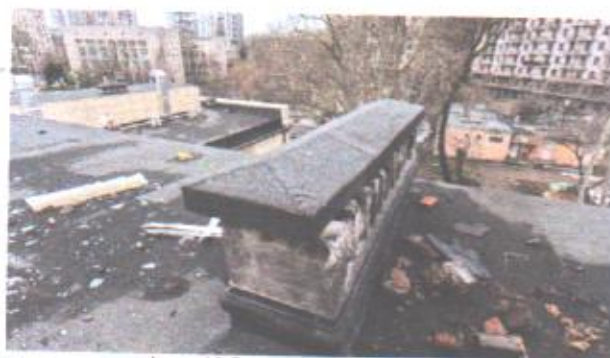
Ventilation shaft walls and associated technical structures sustained extensive damage.

Фото 12 Руїнування вент/каналу

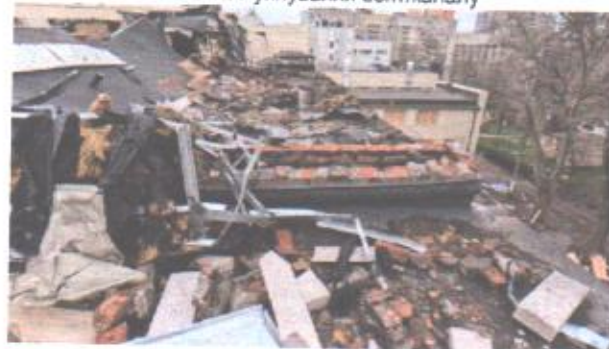
Фото 13 Руїнування надбудови

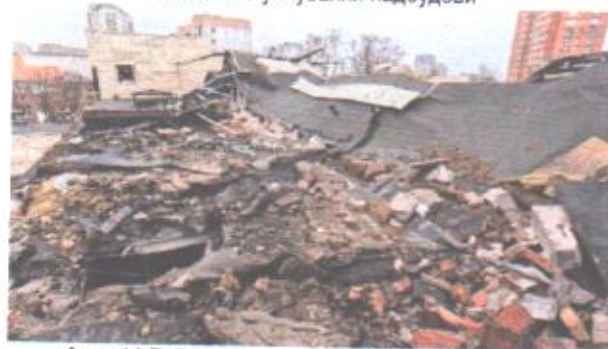
Фото 14 Руїнування надбудови, місце попадання

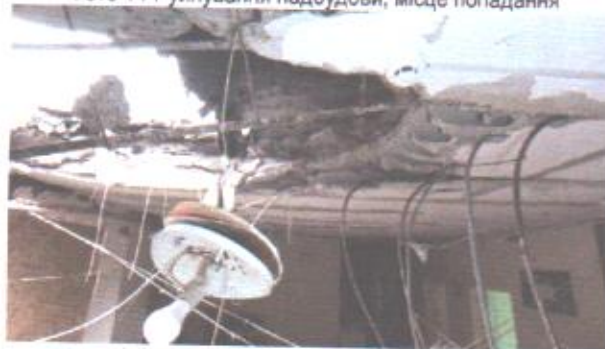
Фото 15 Руїнування плити перекриття

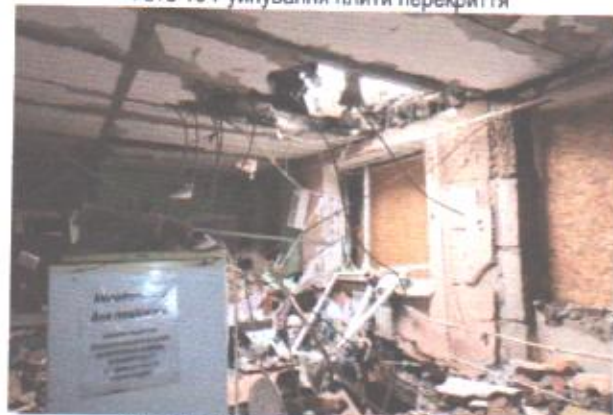
Фото 16 Руїнування плити перекриття

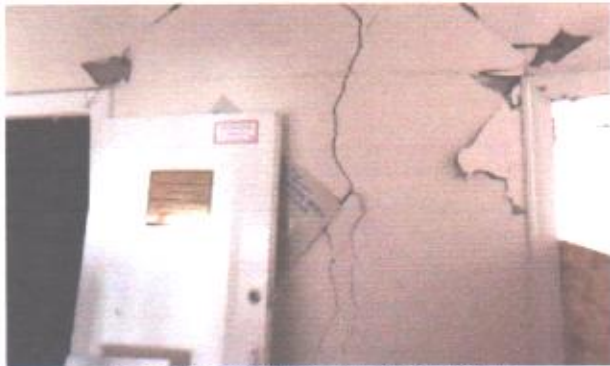
Фото 17 Наскрізнi тріщини в перегородцi

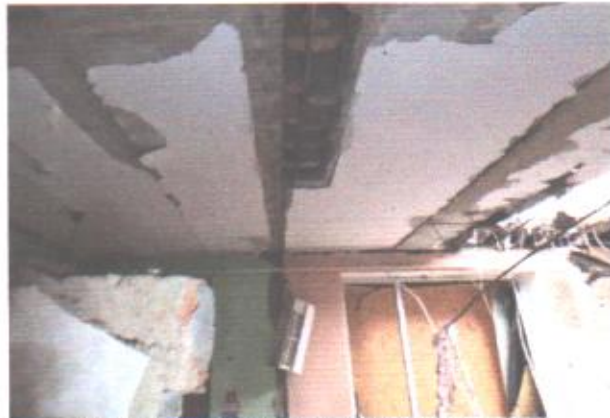
Фото 18 Випадіння розчину зі швів між плитами

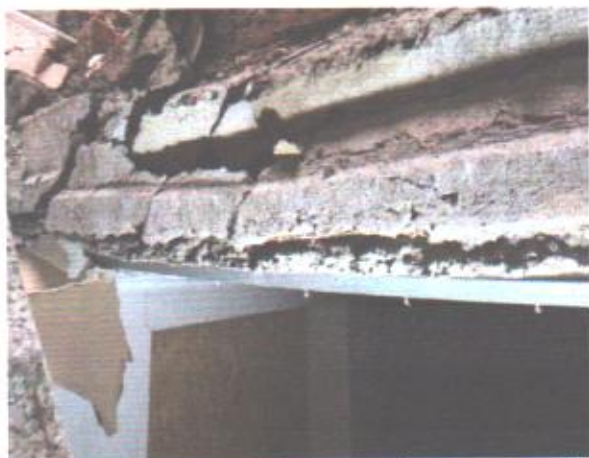
Фото 19 Руйнування плити перекриття 3 поверху в осях 12-13/В-Ж

Damaged reinforced concrete floor slabs shall be dismantled in a controlled and sequential manner.

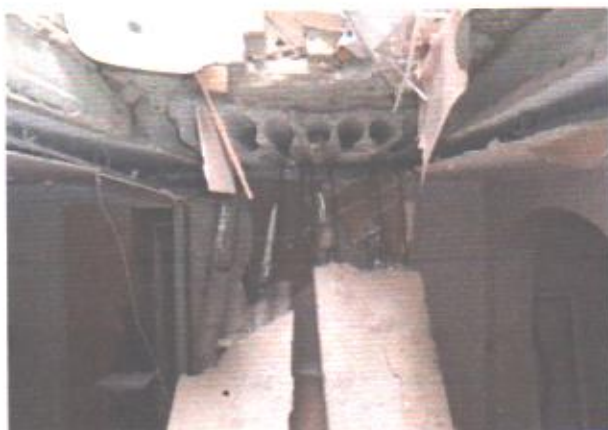
Фото 20 Руйнування плити перекриття, обвалення частини конструкції

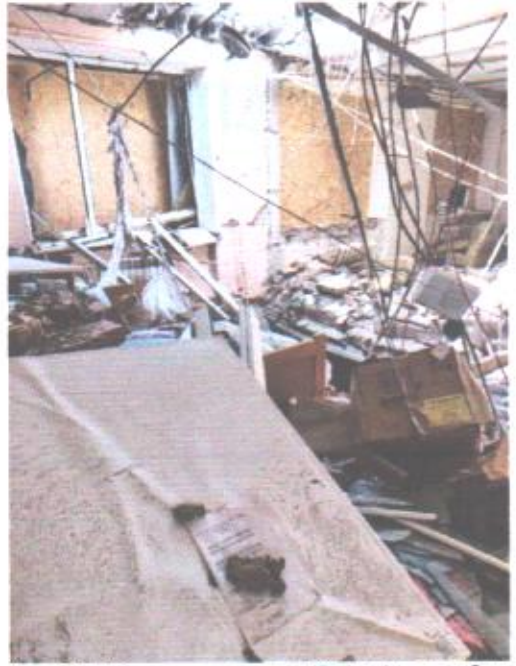
Фото 21 Руйнування конструкцій під місцем вибуху

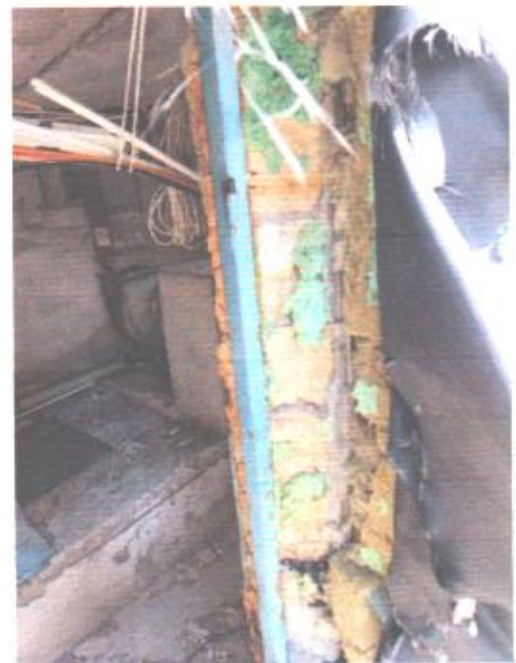
Фото 22 Пошкодження стіни надбудови

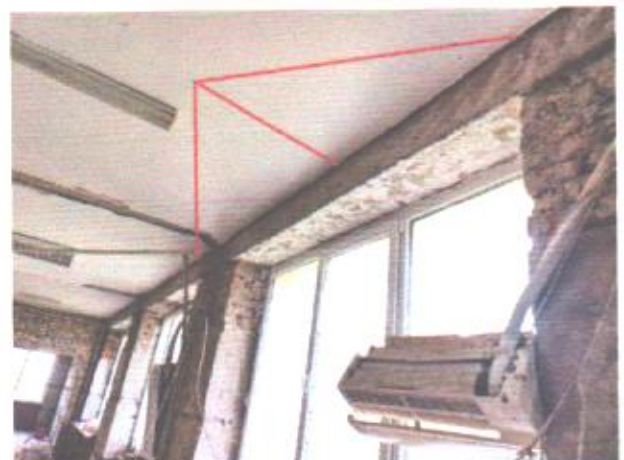
Фото 23 Зміщення плит перекриття із зовнішньої стіни

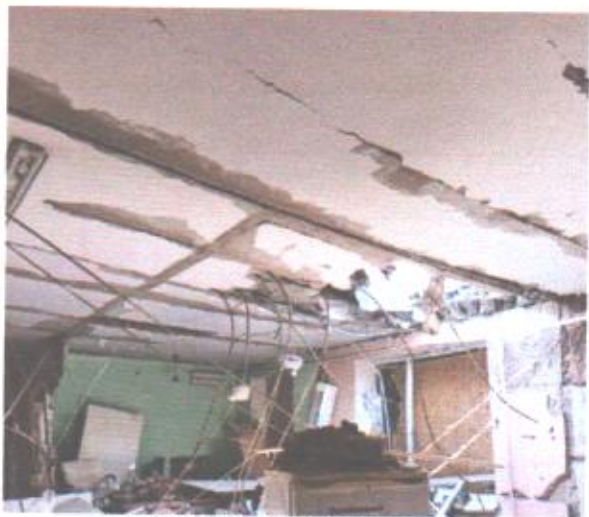
Фото 30 Прогини в плитах перекрытия

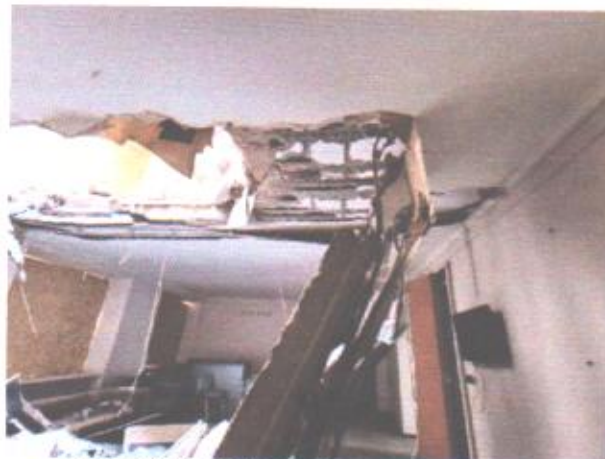
Фото 33 Обваления части плиты перекрытия

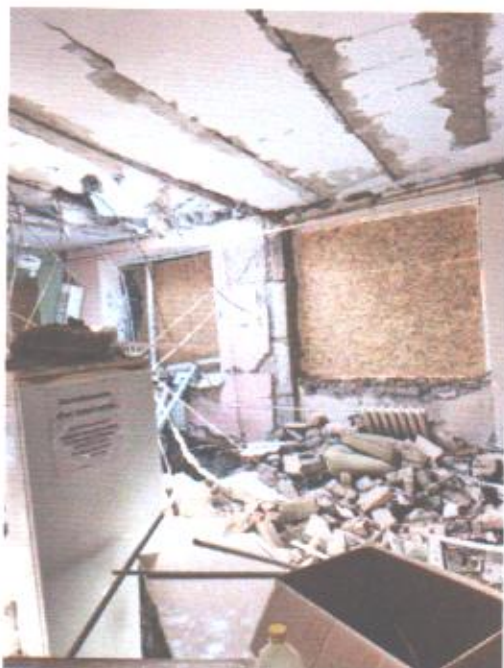
Numerous window and door assemblies were destroyed or rendered unusable.

Фото 31 Руйнування вікон і прорізів

Destroyed windows and openings shall be temporarily sealed.

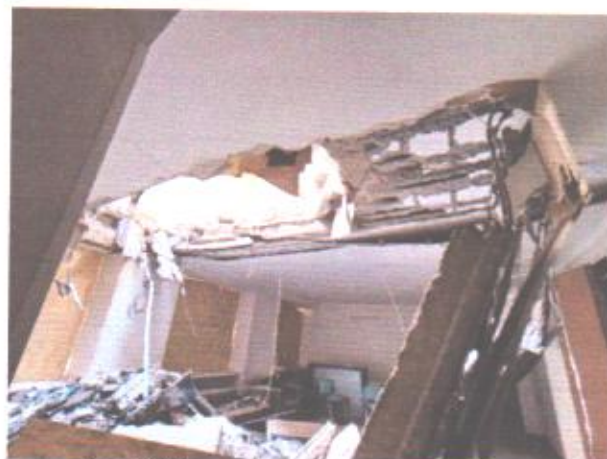
Фото 34 Обваления части плиты перекрытия

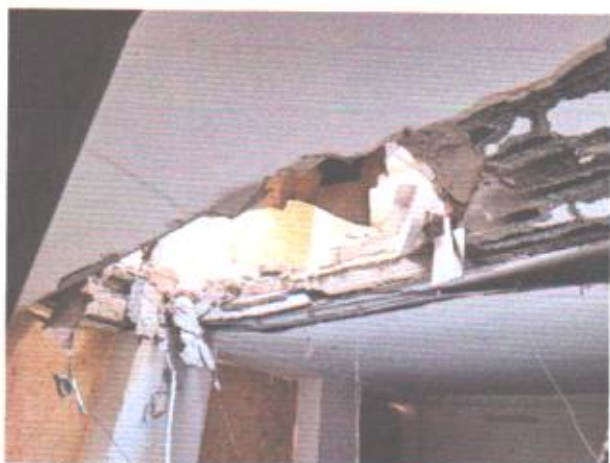
Фото 32 Стан руйнування плит перекрытия між 3 і 4 поверхами

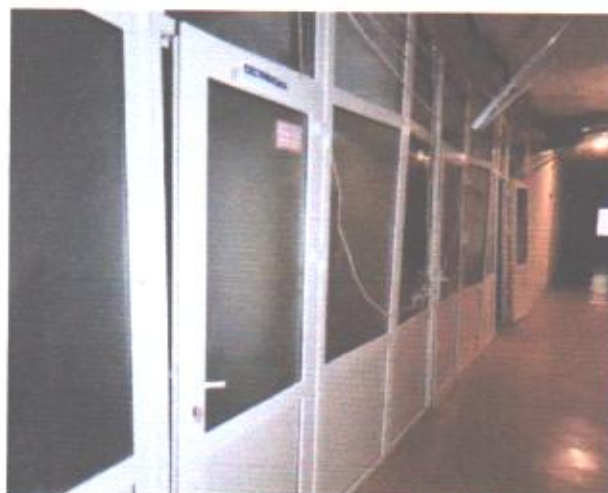
A glazed metal-plastic partition located on the second floor was destroyed.

Фото 35 Руйнування металопластикової перегородки
