Case Report

Intraoperative periprosthetic humeral fracture during reverse shoulder arthroplasty: a sequelae of prior biceps tenodesis

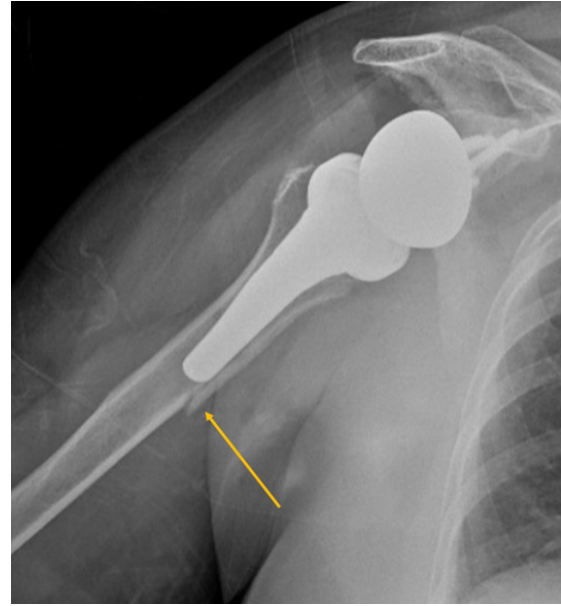
Fig. 2. Intraoperative X-ray showing an oblique fracture of the humerus (arrow) in the patient.

Arthroplasty was performed through a deltopectoral approach using the Aequalis Ascend Flex reverse shoulder system from Wright Medical (Memphis, TN, USA). The surgery was uneventful, and the final reduction was performed using a 6-mm insert for the humeral tray (smallest option). After reduction was achieved, the humeral stem was unstable, and an oblique fracture line was identified involving the site of the osteotomy and exiting through the hole used for anchoring the biceps. An intraoperative X-ray of the shoulder is shown in Fig. 2. The stem was removed, and the fracture was fixed by cerclage using two non-absorbable sutures. The stem was inserted and found to be stable before and after reduction with a 6-mm liner. The procedure was uncomplicated, and the patient wore an arm sling for 2 weeks. Follow-up at 5 months from surgery revealed a stable implant with a good location and good bone healing (Fig. 3).

The periprosthetic fracture was fixed intraoperatively in our patient using a suture cerclage. Several studies have asserted and emphasized the efficiency and safety of using a suture cerclage rather than a stainless steel wire or other methods of fixation [22-24]. This was supported further by the uneventful postoperative course of our patient, who exhibited good bone healing and stability on follow-up (Fig. 3).

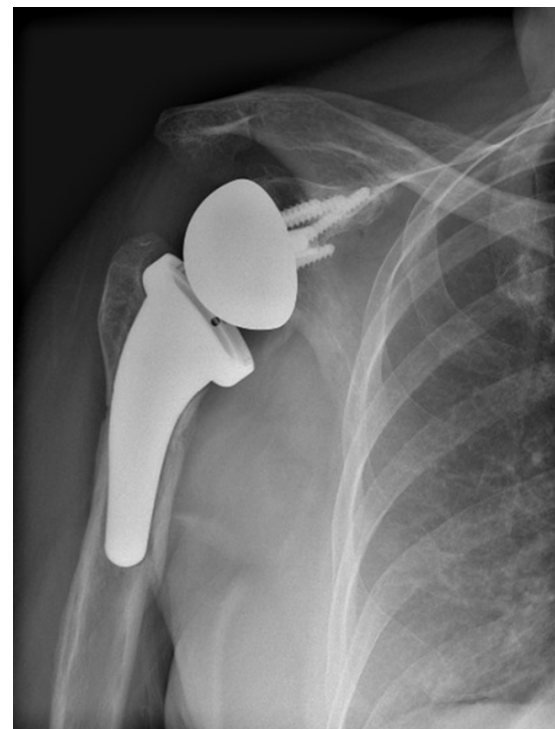
Fig. 3. X-ray of the shoulder at 5-month follow-up showing a stable implant in a good location with good bone healing.
