# Clinical Case Report

As is already widely known, the main characteristic of the Point UV implants is that the long-term tracking of marginal bone shows very stable thanks to the full osseointegration occurring in a very short time of a month in most cases. This results very fast primary stabilization of implants, and the clinician's confidence in the treatment would be maximized with the guaranteed long-term survival rate also.

| **Dr OH HEUIYUNG**

**Dr OH's Dental Clinic, Korea. DDS. MSD**

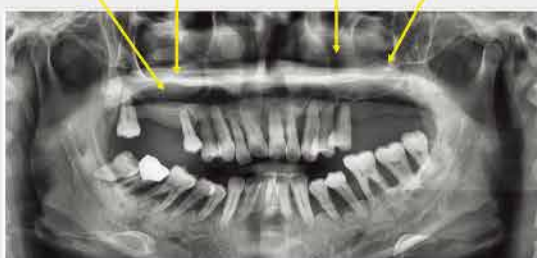
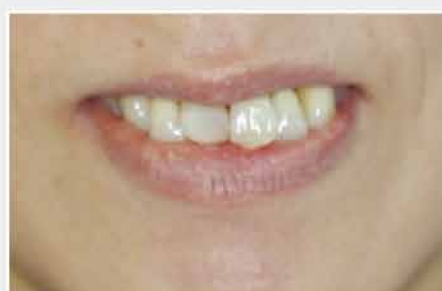
## Admission (2019.1.3)

At the time of admission, most of the teeth were severely affected by tooth decay and periodontitis, to the point where it was difficult to lead a normal social life

Depth of the remaining bone was merely 2mm in both maxilla

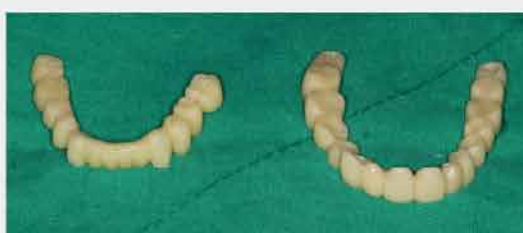
## 1st surgery (2019.1.10)

Implantation in both jaws and sinus lifting

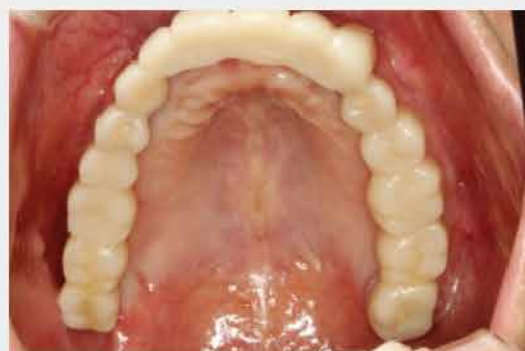
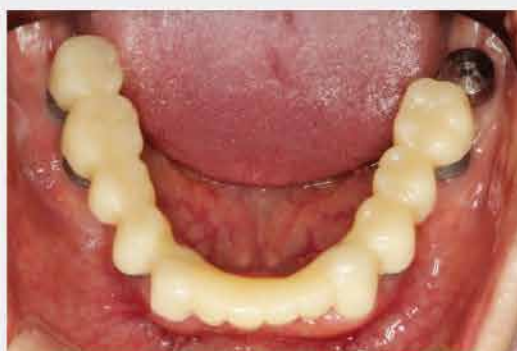
Temporary crown in next day of operation

Provisional implants installation in #18 and #28 for temporary bridge in maxilla

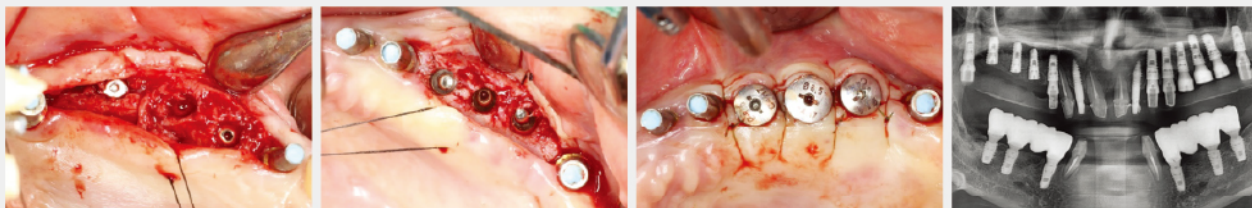
## 2nd surgery (2019.8.13)

Implantation in the sinus area after bone augmentation

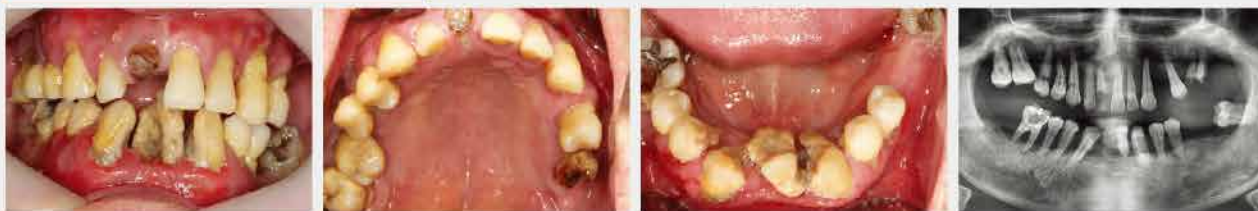
### 1st diagnosis (2018.12.19)

Most of teeth were severely affected by periodontitis

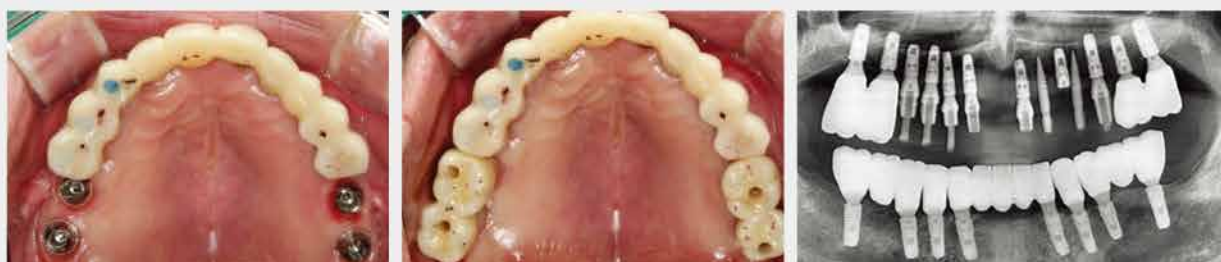
### 2nd prosthetics #43-33, #16,17,26, 27 (2020.5.14)

Both of posterior were scanned simultaneously for prosthetics

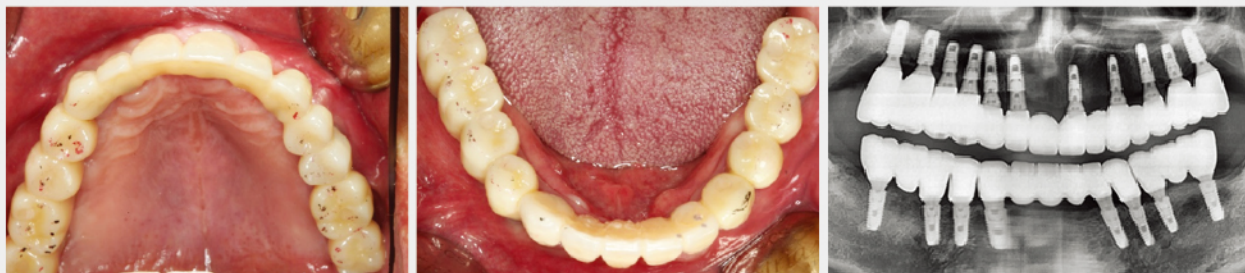
**3rd prosthetics #15-25 (2020.7.14)**

All the Implants look very stable with healthy alveolar bone

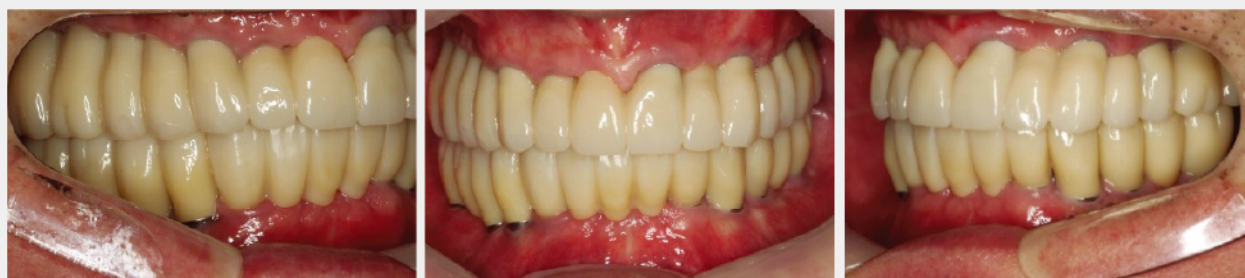
**10 months (2021.2.17)**

All the prosthetics are functioning well with good aesthetics

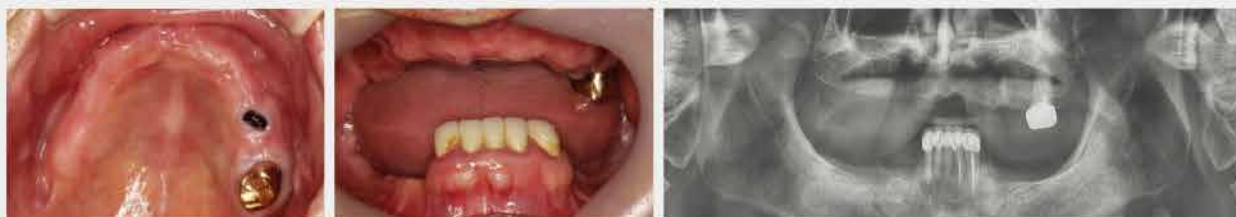
### First visit oral condition and Panorama (2019.2.4)

1st diagnosis shows requiring multiple implant treatments due to the loss of many teeth.

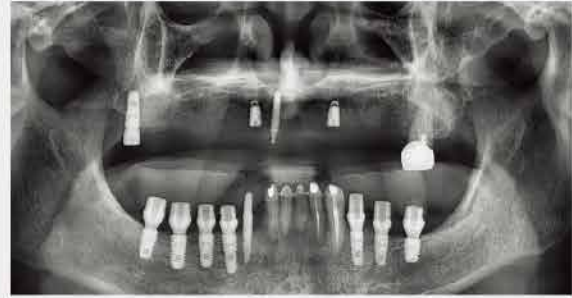
## After 1st alveolar ridge splitting

Temporary implant & support implant placement : denture function protects the GBR area and increases denture retention.

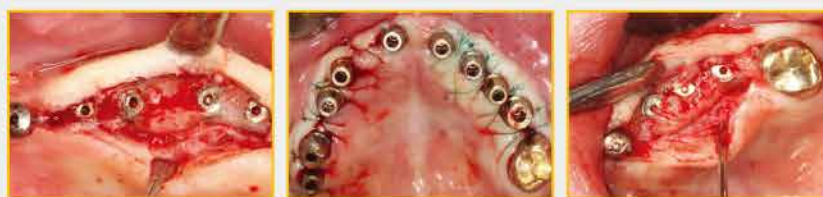
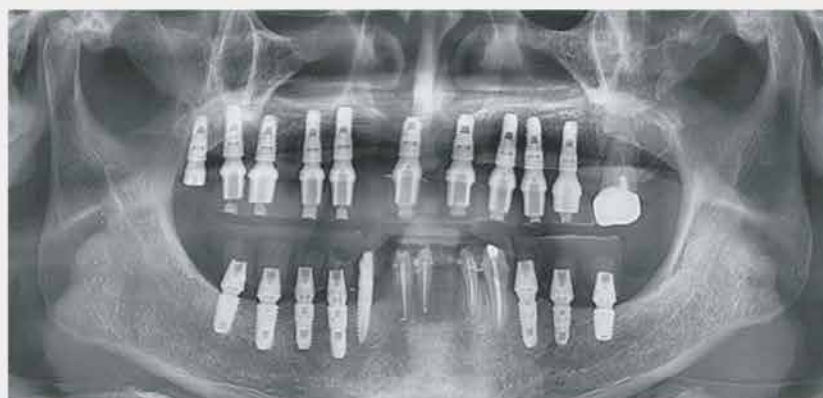
## 2nd surgery : 6 months after maxillary implant placement

### 2nd surgery 6 months after implantation

1. Confirm that enough alveolar bone covers the cover screw.
2. After fixing the abutment at the same time the provisional restoration is installed to improve the function.

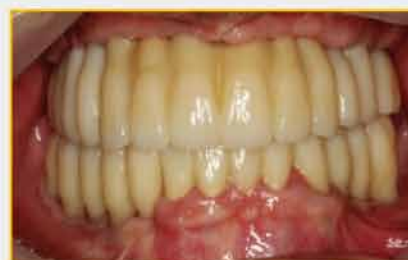
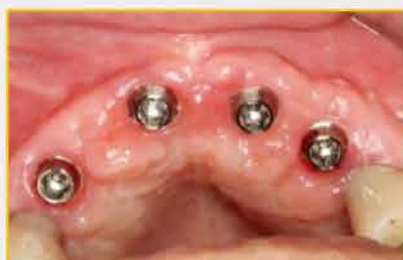
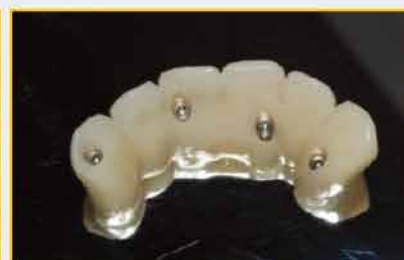
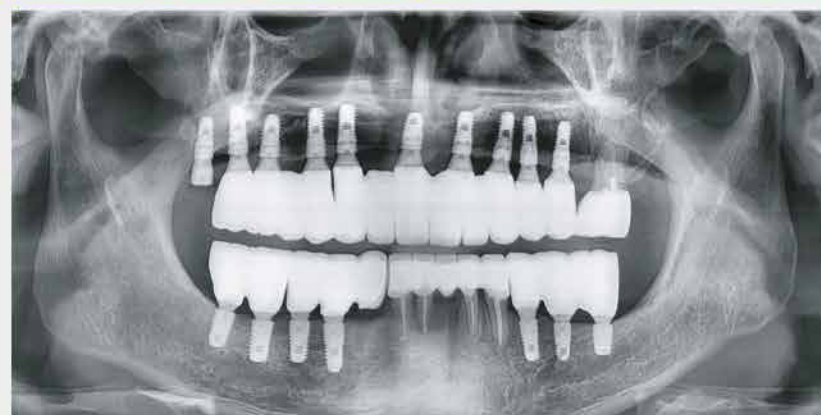
## End of treatment

Completed prosthesis with screw type for both anterior and posterior teeth.

Treatment period :  
1 year and 9 months.

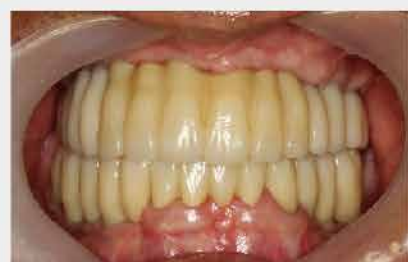
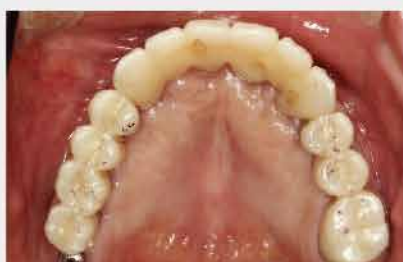
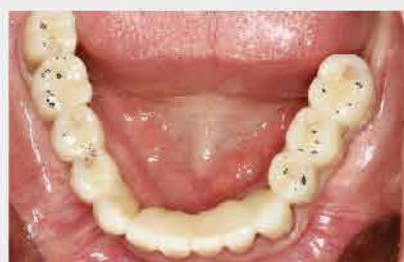
## 1Y Re-call check up

Function and aesthetic stability shows very stable in a regular check-up for 1 year.

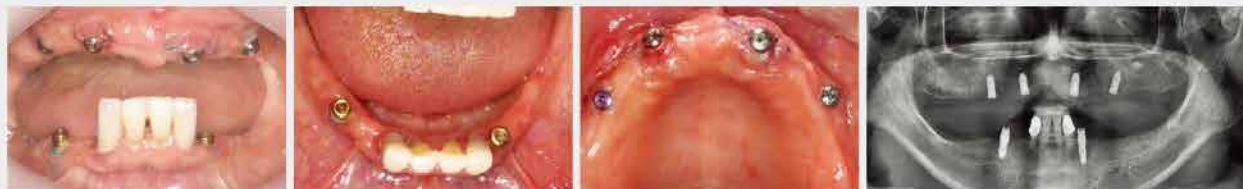
### First visit ; intraoral condition & panoramic radiograph (2022.7.15)

1st admission shows all the pre-installed implants by other clinic need replaced due to bone resorption

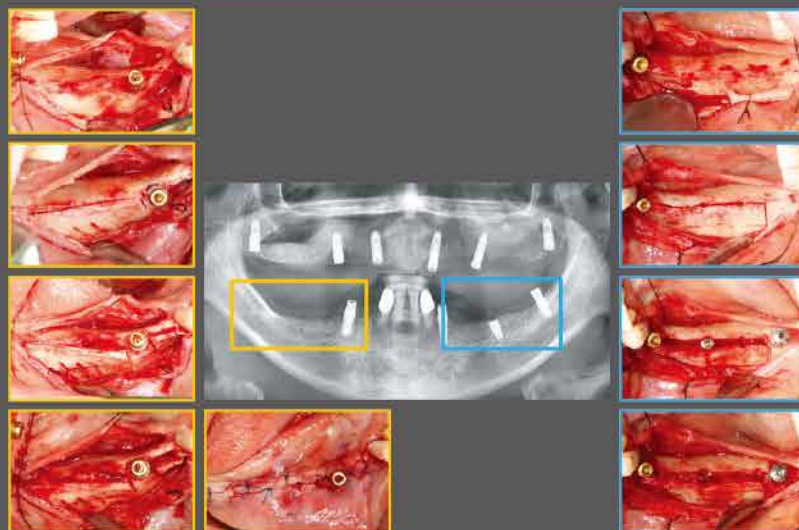
### Mandibular ridge splitting with supporting implants placed

1. Rt side :  
Buccal plates got separated during the ridge split, so expansion was made with bone chips only
2. Lt side :  
Normal ridge split with a supporting implant installation

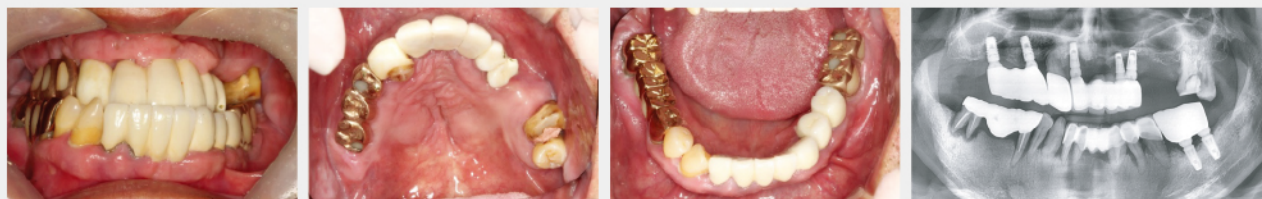
### First visit : intraoral condition & panoramic radiograph (2021.7.2)

#### C/C : implant failure & peri-implantitis

1. Implant treatment completed 5 years ago
2. Functional dysfunction due to recent implant inflammation
3. Class III malocclusion & cleft lip and palate
4. Patients requiring a very complex treatment process

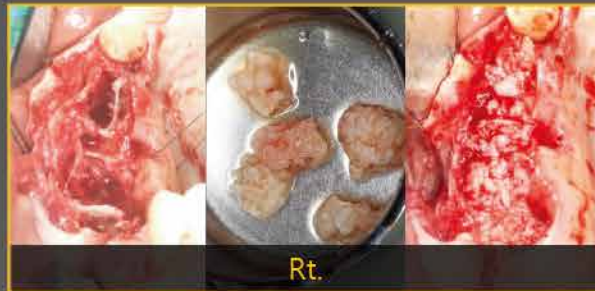
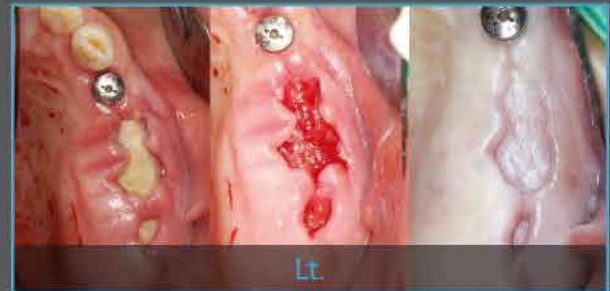
Upper Rt GBR & Lt immediate implant placing after extraction

## Maxilla

Transplantation of autogenous bone to increase bone density

## Mandible

Implant placement after ridge splitting to solve the reduced bone width

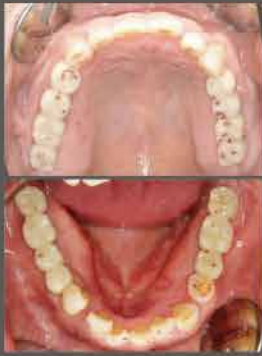
## Intraoral condition after treatment

Peri-apical radiograph shows perfect osteointegration of marginal bone of implant

In the case of a bone level implant, it is more stable if placed 2-3mm under than the alveolar crest level.

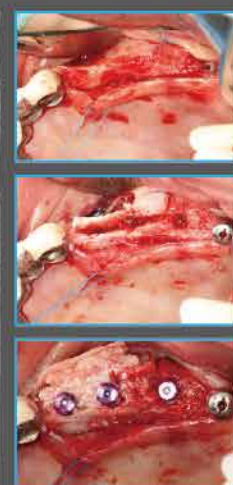
## Posterior maxilla ridge split and installation

#15,16  
Re-split and install

#24,25,26  
Split and install

Supporting implants were installed  
for immediate usage of denture and protection of the surgery area
